# Risk Assessment Strategy for Corrosion Under Insulation of Nano Technology Insulation on Geothermal Pipeline

Journal of Mechanical Engineering,  
Science, and Innovation  
e-ISSN: 2776-3536  
2022, Vol. 2, No. 2  
DOI: 10.31284/j.jmesi.2022.v2i2.3199  
ejurnal.itats.ac.id/jmesi

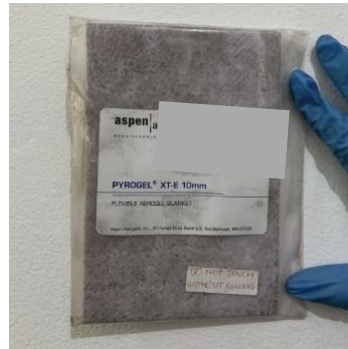
**Figure 5.** Nanotechnology insulation material

Aerogel has various types, one of them is “nanotechnology additive insulation” is shown in Figure 5. In the final report issued by Aerogels vendor, it is stated: that nanotechnology insulation material has a level of high-water resistance through test use ASTM C1511 method with results shown in Table 3.
