# Analysis of Coastal Abrasion Rate of Laha Village Ambon City Using Satellite Data

Zulfikri Samallo, Warniyati, Tri Octaviani Sihombing\*, Monica R. Tutkey

<sup>1,2,3,4</sup>Department of Civil Engineering, Pattimura University Ambon

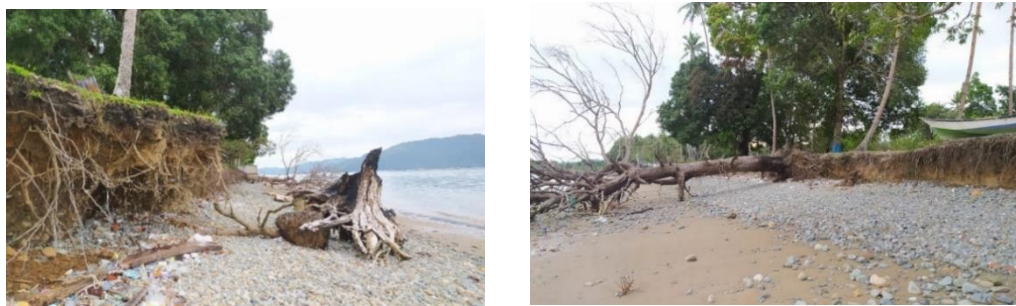
**Figure 1. Trees Falling on the Beach**

The damage at Laha Beach can be seen in Figures 1, which are the collapse of trees on the beach due to abrasion and also the foundations of former buildings on the beach as shown in Figure 2. Initially, the former building was on land and far away from the shoreline but over time, due to abrasion that occurs, the shoreline has shifted past the former building and the collapsed tree.

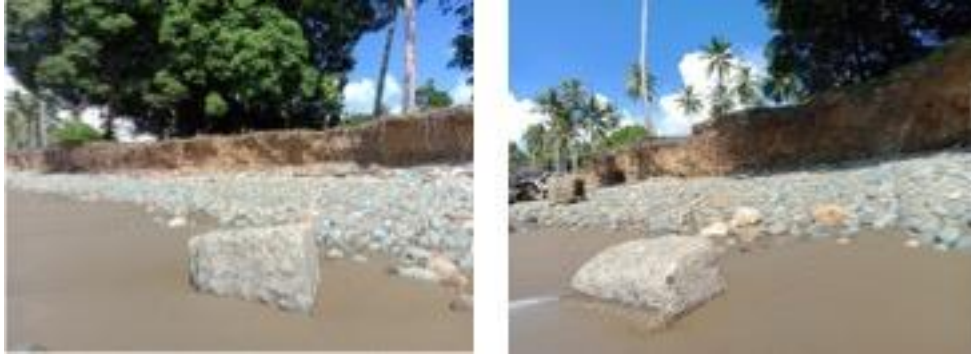
**Figure 2. Trees Falling on the Beach**

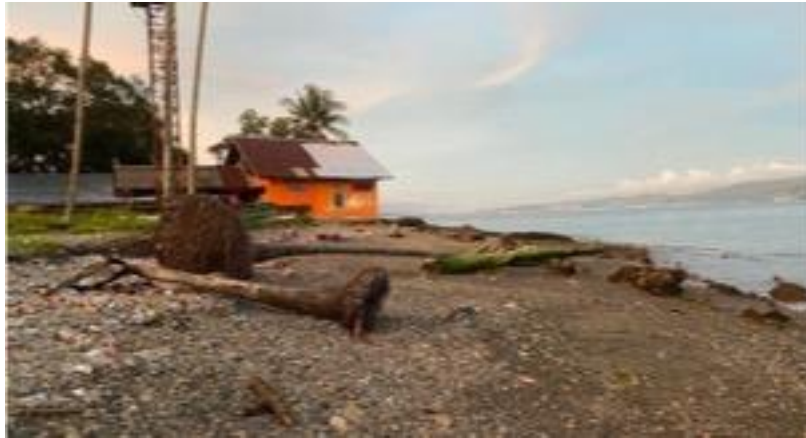
**Figure 5. Beach Abrasion Condition (November 23, 2022)**

This research was conducted along the coast of Laha Village, Ambon City, Maluku Province. The research time is planned within 2 months. The location map and pictures of the current beach conditions are shown in Figure 4 and Figure 5.

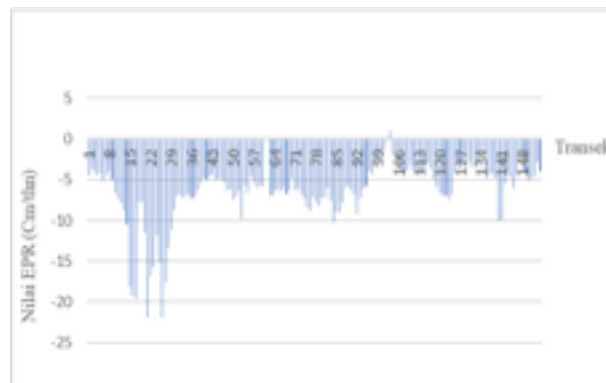
**Figure 8. Graph of beach change in Laha Village 2013-2022 using EPR method**

Figure 7, Figure 8, and Figure 9 below are graphs of changes in the coastline of Laha Village using three methods contained in DSAS including NSM, SCE, and EPR. This graph illustrates the level of change and the rate of abrasion on the Laha Village Beach for the period 2013-2022.
