Risk Assessment Strategy for Corrosion Under Insulation of Nano Technology Insulation on Geothermal Pipeline

Journal of Mechanical Engineering,
Science, and Innovation
e-ISSN: 2776-3536
2022, Vol. 2, No. 2
DOI: 10.31284/j.jmesi.2022.v2i2.3199
ejournal.itats.ac.id/jmesi

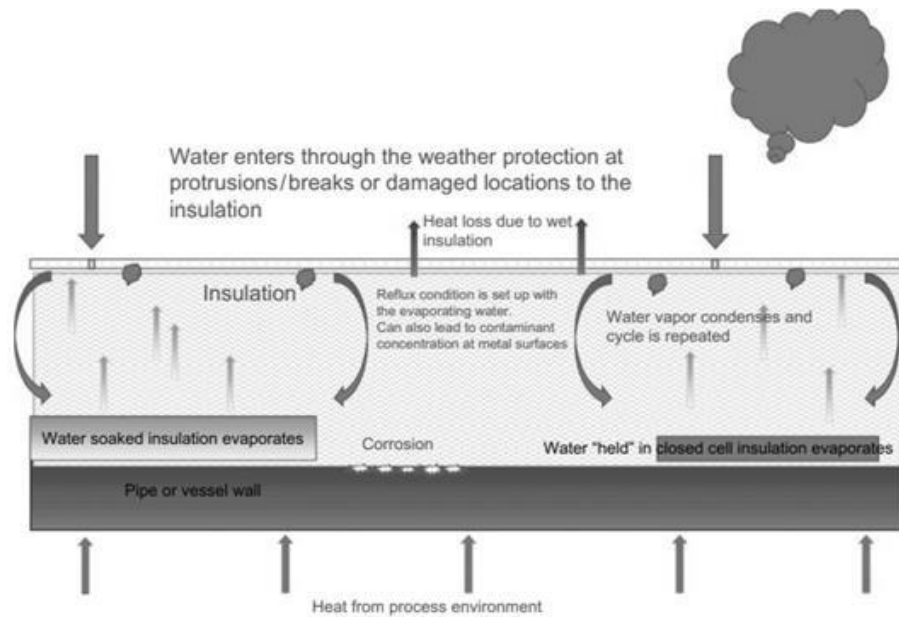
Figure 3. Mechanism formation of CUI [5]

The mechanism of the formation of CUI can be seen in Figure 3. Risk the occurrence of CUI at operating pipe temperature 50 - 175°C than temperature work other with the same conditions. Risk The occurrence of CUI is also increasing significantly with the increased existence possibility of insulation *leaks*/blister and causing water and air to penetrate into the insulation and reaction with the pipe surface [14]. For monitoring the risk due to corrosion based on the temperature operation shown in Table 1.

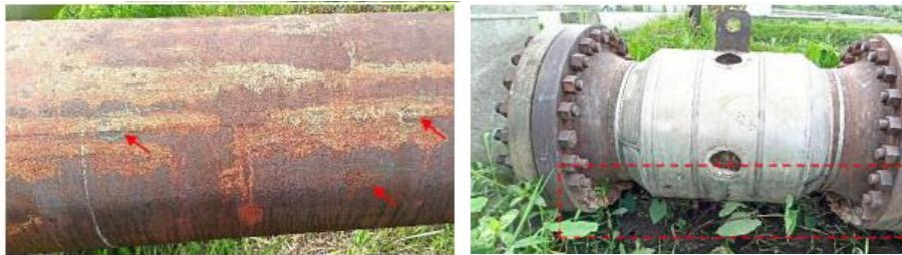
Figure 4. CUI indicates on the pipe in the X field [15]

In general, CUI does not occur in the main geothermal pipelines due to the high operating temperature of around 200°C. However, there is a CUI situation that can occur in the geothermal X field shown in Figure 4., where some piping is operated intermittently such as auxiliary pipe or drill pipe, bleed line from wellhead to flash-tank/sumps, drain line from well piping to flash - tanks/sumps, blowdown lines in separators, drains from separators, etc. In addition, a special case is the potential CUI damage to a 30"/24" insulated air duct, from field X-1 to field X-2, which is functionally converted as a condensate line operating at temperatures around 50°C (within the CUI temperature range) [15].
