J E M T
Journal of Earth and Marine Technology
homepage URL: ejurnal.itats.ac.id/jemt

Identification of the Overall Slope Pit Angle Value for Erosion Control in Disposal Land

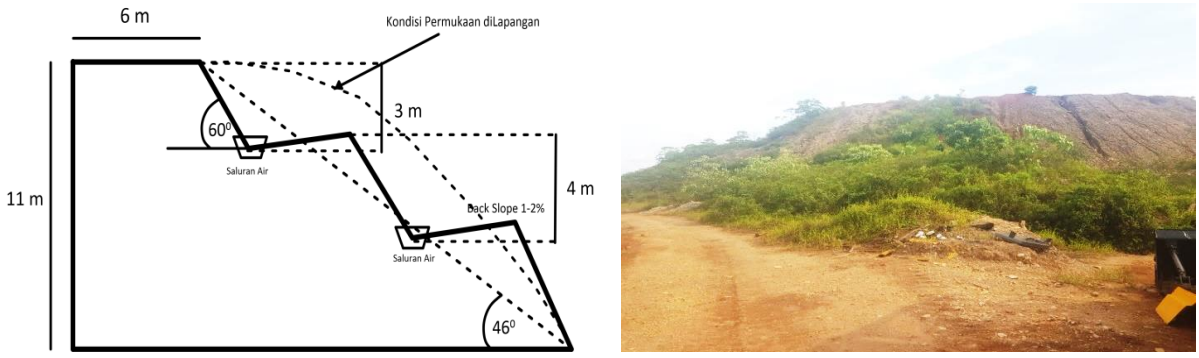
The condition of the soil surface in the disposal area was found to have gully erosion, where this condition occurs indicating that the disposal area is partially covered by vegetation and is prone to the resulting amount of erosion, see figure 1 on the right. The disposal land that is inactive for a long time will have a wide impact on the possibility of loss of soil cover and the instability of the disposal condition due to erosion, besides that the disposal area has not received special action in erosion control. The form of gully erosion on the surface of the soil that occurs in the disposal area can reduce soil productivity if special handling is not carried out regarding the amount of erosion produced. Erosion that occurs at the research location is caused by the water medium in the process of moving or transporting soil material from one place to another.

The results of calculations using the USLE (Universal Soil Loss Equation) method, the amount of erosion that occurs on disposal land is 123.43 tons/ha/year, see table 4 with a medium erosion hazard category ranging from 60-180 tons/ha/year, see table 3 which shows the condition of disposal in the form of open land cover/without revegetation with a factor value of 1, see table 1.

Figure 1. Recommended Bench Terrace (left), Disposal Land (right)

The land arrangement activity uses excavated soil from a former coal mine by forming bench terraces with an inward slope, the aim of which is to do so that the rainwater that falls does not flow directly to the next level. Bench terraces are a conservation technique and an appropriate measure to reduce erosion. The results showed that for the dimensions of bench terraces recommended on disposal land, the overall slope pit angle value was $46{,}6^0$, see table 5, with a maximum single slope pit angle on the bench of 60^0 (16.6%).

Application of bench terraces is expected to inhibit the rate of erosion and reduce the amount of lost soil cover. With soil conservation measures in the form of traditional terraces in the form of bench terraces with a factor value of 0.4, see table 1. Erosion that occurred on disposal land decreased 123.43% (tons/ha/year) to 49.37 tonnes/ha/year, see table 4, with a low erosion hazard category, see table 3 in the range between 15-60 tons/ha/year, and or about 39% reduction in erosion that occurs.
