Risk Mitigation of Workplace Accidents in Oil Palm Plantations by Using HIRADC and FTA Approaches (Case Study: PT. XYZ)

Nur Rachmawati Sutriono Putri[1], Muhammad Nur[2*], Suherman[3], Nazaruddin[4], Muhammad Isnaini Hadiyul Umam[5]

Industrial Engineering Study Program, Faculty of Science and Technology, Sultan Syarif Kasim State Islamic University of Riau, Pekanbaru

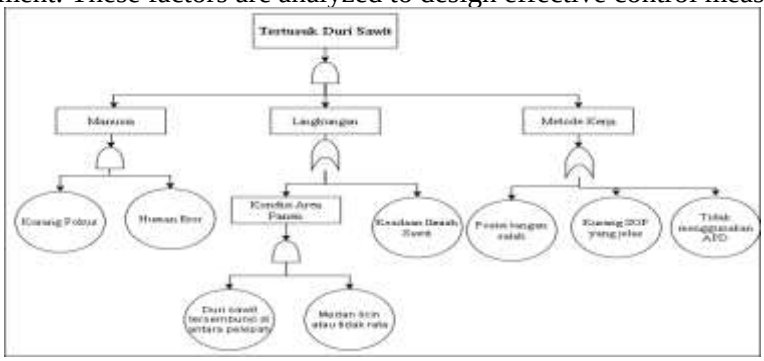
Figure 2. Fault Tree Analysis for Pricked by Palm Thorns

a. Fault Tree Analysis for Pricked by Palm Thorns. In this analysis, various factors contributing to workers being pricked by palm thorns are identified, including tool conditions, work methods, and the work environment. These factors are analyzed to design effective control measures.

that all workers use adequate personal protective equipment (PPE), such as thorn-resistant gloves. Regular training on proper PPE use is also necessary to ensure workers understand the importance of using PPE effectively. Human error and lack of focus are major contributors to this risk. Therefore, the company should conduct comprehensive training for workers, which should include information on the dangers of palm thorns, safe work practices, and correct PPE usage. This training should be conducted regularly, at least once a month. Additionally, implementing a work rotation system can help reduce fatigue, which contributes to decreased concentration. Daily supervision by field supervisors should also be conducted to provide direct feedback on unsafe work practices. The condition of the harvest area, such as hidden thorns among fronds, slippery terrain, and palm tree condition, requires intervention through workplace maintenance. Preventive actions include regular cleaning of pruned palm fronds to reduce the risk of workers unintentionally touching hidden thorns. Furthermore, harvest paths should be leveled and anti-slip materials used, particularly in high-sloped areas, to reduce the risk of slipping. Simple sensing tools, such as lightweight thorn detection sticks, can help workers identify potentially hazardous areas before transporting palm fruit bunches. A clear and standardized SOP must be designed and implemented for all processes in the palm plantation. This SOP should cover how to transport fruit bunches, proper hand positions when using tools, and correct use of tools like tojok and egrek. SOP documentation should be published in work areas in the form of visual guides that are easy for all workers to understand. Additionally, periodic evaluations of SOP implementation are required to ensure that field practices align with the established procedures. Work scenario simulations focusing on safe body and hand positions should also be incorporated into regular training. Using PPE, such as Kevlar gloves and anti-slip boots, should be mandatory for all field workers. To improve compliance, the company can provide high-quality PPE for free and ensure an adequate supply. Additionally, regular inspections and maintenance of tools like tojok and egrek should be part of the safety management program. Broken or dull tools must be repaired or replaced immediately to prevent accidents from using faulty equipment. As an additional measure, innovations such as polymer transport containers can be implemented to minimize direct contact with palm thorns. These containers should be designed ergonomically to facilitate safe transport without compromising worker safety.

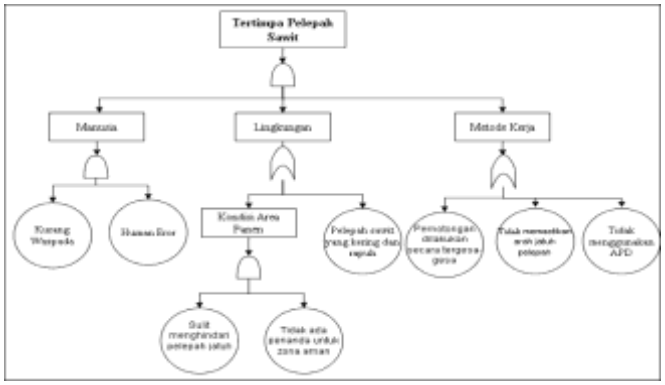
Figure 3. Fault Tree Analysis for Being Struck by Palm Fronds

This analysis aims to identify the root causes of workers being struck by palm fronds, focusing on safety factors during the cutting and felling of fronds, as well as workers' awareness of surrounding risks.

(b) Falling Palm Fronds: To address the risk of falling palm fronds, it is crucial to improve safe cutting techniques in accordance with established procedures. Training workers on proper cutting techniques will help prevent this hazard. Additionally, regular monitoring of the work environment is necessary to ensure that the work area is free from hazards like falling palm fronds. Lack of worker awareness during harvesting activities is a major cause of accidents involving falling palm fronds. Therefore, the company should hold routine training to increase awareness of this danger. The training should include lessons on environmental observation techniques, identifying hazard zones, and safety procedures before cutting fronds. Scenario simulations of falling fronds can be conducted to train workers in quickly avoiding dangerous situations. Moreover, implementing a communication system using voice or visual signals among workers will help improve coordination, especially when cutting fronds. A work area without a clearly marked safe zone poses a significant risk. To address this, the company must implement a system of marking work zones using safety tape or visible signs. Before cutting begins, workers must mark the area where fronds will fall within a certain radius to ensure no other workers are in that area. Furthermore, the work environment should be periodically organized to avoid piling up dry fronds, which could create additional hazards like slipping or increasing the workload during removal. This organizing should be supervised by personnel qualified in safety management. Cutting techniques that do not consider the direction of falling fronds are a primary cause of accidents. Therefore, the company should develop and socialize an SOP for safe cutting techniques. The SOP should explain the optimal cutting angles to ensure the fronds fall in a controlled manner and do not harm workers. Additionally, using tools such as frond hooks or supports can help direct the fronds to a safe location. These tools also enhance worker control over the direction of the falling fronds, especially when working with tall or hard-to-reach trees. Regular inspections of these tools should be conducted to ensure their functionality. Appropriate PPE, such as safety helmets and anti-slip boots, must be applied to all workers involved in harvesting. The company must ensure that sufficient PPE is available and that workers wear it at all times while working. Additionally, field supervision by safety officers should be enhanced to ensure compliance with SOPs and PPE usage. This supervision will also

provide direct evaluations of the implementation of taught cutting techniques and correct unsafe practices. Periodic evaluations of the effectiveness of these measures should be conducted to ensure continuous improvement in workplace safety.

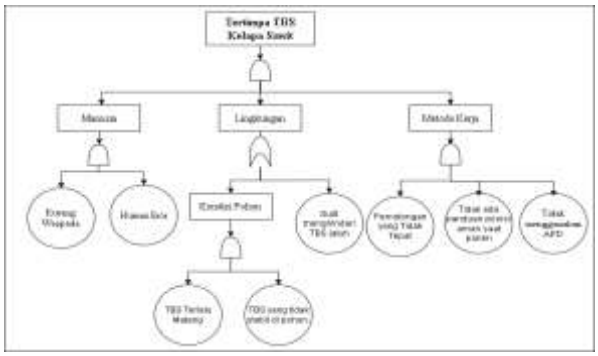
Figure 4. Fault Tree Analysis for Being Struck by Palm Oil Fruit Bunches (FFB)

c. Fault Tree Analysis for Being Struck by Palm Oil Fruit Bunches (FFB)
Through this analysis, the main causes of workers being struck by FFBs are mapped, ranging from transportation techniques to work positioning arrangements, in order to significantly reduce this risk.

(c)To reduce the risk of falling FFB, an improvement is implementing safe FFB transport procedures. The use of appropriate transport equipment, such as trucks or transport vehicles that are strong and stable, can reduce the likelihood of accidents during FFB transportation. Workers should also be trained on safe transport methods, including how to properly load and manage the weight to prevent uncontrolled transportation and accidents. Intensive safety training should be a priority to prevent accidents caused by inattention or human error. This training should include recognizing signs of overripe or unstable FFB on trees at risk of falling. Workers should also be taught techniques for assessing the environment before starting the harvesting process, ensuring a safe position away from the risk of falling FFB. To enhance awareness, the company can provide a simple alarm system using whistles or visual signals, which workers can use to alert colleagues when FFB is about to be cut. A safe work environment is crucial for reducing the risk of injury. The company should ensure that only FFB with optimal ripeness is harvested to reduce the risk of overripe fruit falling by itself. Regular monitoring of tree conditions should be carried out by dedicated personnel to assess the stability of FFB. Additionally, work paths around harvest areas should be designed to be free from obstacles and equipped with signs indicating safe positions for workers. This step can minimize potential injuries from mispositioning or accidentally being under a tree at risk of falling fruit. The development and socialization of an SOP for FFB cutting is an important step in preventing accidents. This SOP should include guidelines for safe positions during harvesting, correct cutting techniques to prevent uncontrolled FFB falls, and steps to take if FFB begins to move. Tools such as extended poles with supports or collecting baskets should also be provided to ensure FFB does not fall directly onto the ground or workers. Workers should receive regular training on how to implement these SOPs, and field supervision should be conducted to ensure compliance with the procedures.Workers are required to use PPE designed to protect from falling FFB. Safety helmets with additional impact-absorbing protection should be standard equipment. Additionally, the company needs to provide transport vehicles with added safety features, such as load restraints made of mesh or strong tarpaulins, to ensure FFB does not fall during transport. Routine inspections of the transport equipment should be conducted to ensure structural integrity. This inspection should also cover transport paths to ensure there are no obstructions or terrain conditions that could increase accident risks.

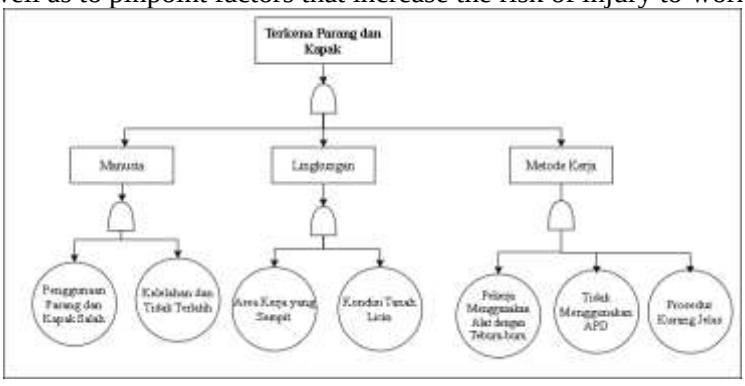
Figure 5. Fault Tree Analysis for Injury from Machetes and Axes

d. Fault Tree Analysis for Injury from Machetes and Axes
This analysis aims to identify the root causes of accidents caused by the use of machetes and axes in the workplace, as well as to pinpoint factors that increase the risk of injury to workers.

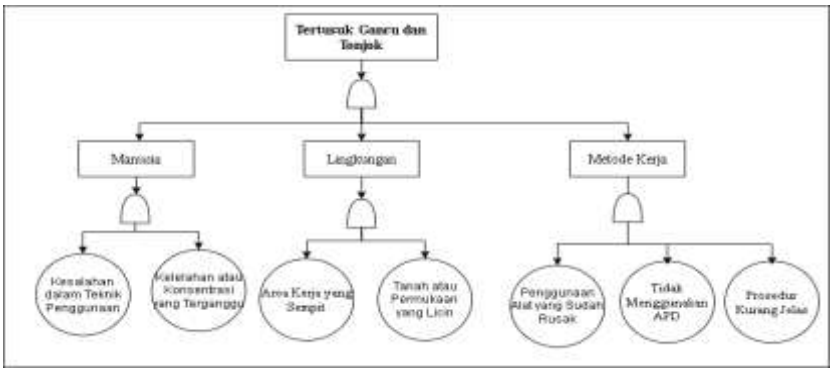
Figure 6. Fault Tree Analysis for Puncture from Tojok and Gancu

e. Fault Tree Analysis for Puncture from Tojok and Gancu
This analysis aims to identify the root causes of accidents caused by punctures from the tojok or gancu, as well as to evaluate the factors that contribute to injuries among workers when using these tools.

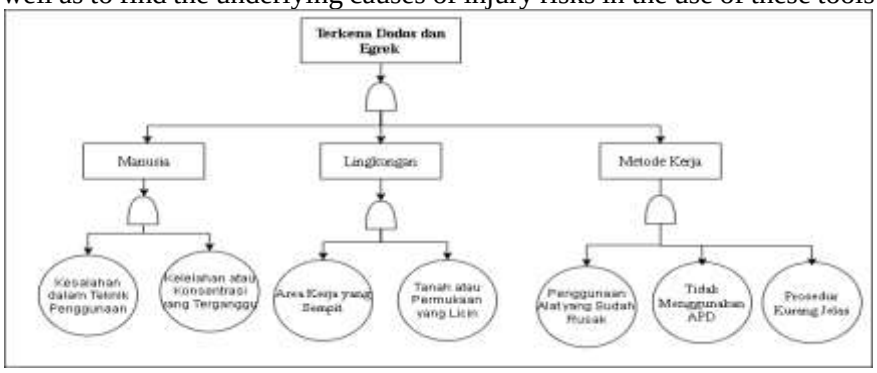
Figure 7. Fault Tree Analysis for Injury from Dodos and Egrek

f. Fault Tree Analysis for Injury from Dodos and Egrek
This analysis aims to identify the root causes of accidents resulting from injuries caused by dodos and egrek, as well as to find the underlying causes of injury risks in the use of these tools in the field.

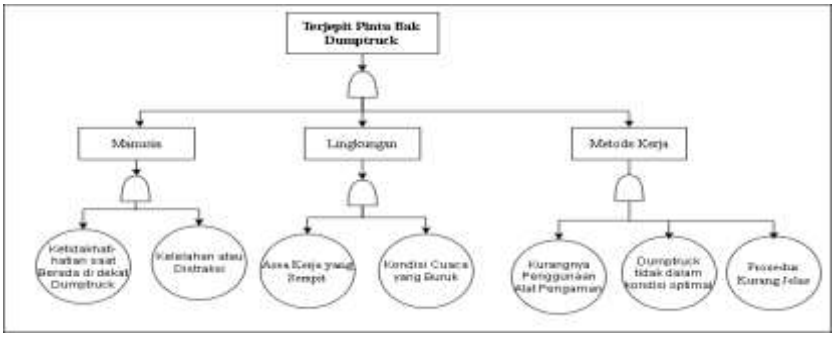
Figure 8. Fault Tree Analysis Trapped in Dump Truck Door

g. Fault Tree Analysis for Pinched by Dump Truck Tailgate
This analysis aims to identify the root causes of accidents caused by workers being pinched by the dump truck tailgate, as well as to identify preventive measures that can be applied to reduce the risk of injury.

(d) Pinched by Dump Truck Bed Door. To prevent accidents caused by being pinched by a dump truck bed door, the first step is to ensure the presence of a clear Standard Operating Procedure (SOP) regarding the operation of the bed door. Dump truck operators should be trained to open and close the bed door carefully and check for the presence of other workers around the vehicle before continuing their operations. Additionally, the use of communication tools, such as whistles or radios, will help operators coordinate with workers on the ground to avoid accidents. The first step is to implement safe work procedures for opening and closing the dump truck bed door. It is recommended that this process be carried out by more than one person to ensure proper control and reduce the risk of accidents. Alternatively, the use of automation technology, such as hydraulic systems or automatic hinges, could be a safer solution. This system allows the door to be opened and closed without direct human involvement, thus avoiding the potential for pinching that often occurs due to accidents or lack of coordination. Workers interacting with the dump truck door must be equipped with appropriate Personal Protective Equipment (PPE). The use of anti-slip safety shoes is crucial to prevent workers from falling or slipping when near the dump truck bed door. Additionally, upper body protection (such as vests or chest protectors) can help reduce the impact of injuries if pinched. This PPE must always be worn by any worker interacting with the dump truck, whether opening or closing the bed door. Workers must receive specialized training covering safe methods for opening and closing the dump truck bed door and how to act when near a moving door. This training should include the proper techniques for using safety tools and avoiding risky positions when close to the bed door. Additionally, workers need to be educated on the importance of maintaining a safe distance and always adhering to the established safety

procedures. Regular inspections of the dump truck's condition are essential to prevent potential accidents caused by equipment failure. Components related to the opening and closing of the bed door, such as hinges, hydraulic systems, and door locking mechanisms, should be inspected regularly to ensure everything is functioning properly. If damage or wear is found, immediate repairs or replacement of components should be carried out to prevent accidents that could harm workers.
The area around the dump truck bed door must be kept clean and free of obstacles or objects that could obstruct the door when it is opened or closed. Before opening the door, ensure that no objects block the door's movement. By maintaining cleanliness and orderliness in the work area, the likelihood of obstacles that could cause the door to malfunction is minimized.
Strict supervision is also needed to ensure that all safety procedures are correctly implemented. Supervisors should always monitor dump truck operations to ensure that workers are wearing protective equipment and following safe procedures when interacting with the dump truck bed door. With consistent supervision, the potential for accidents can be reduced, and workplace safety will be better ensured.
