## Analysis of Water Quality in Abandoned Illegal Gold Mining Pit in Ketapang Regency, West Kalimantan, Indonesia

Abandoned illegal gold mining pits in Ketapang Regency, West Kalimantan, Indonesia, have the potential to pose significant environmental risks due to residual contaminants from gold extraction processes. This study aimed to evaluate the water quality of such mining voids in accordance with the Indonesian Government Regulation No. 22 of 2021 (Annex VI) on surface water quality standards. The research team collected water samples from ten randomly selected points and analyzed them for cyanide (CN<sup>-</sup>), mercury (Hg), temperature, pH, and total dissolved solids (TDS). The results showed that cyanide concentrations ranged from 0.0930 to 0.178 mg/L, exceeding the regulatory threshold of 0.02 mg/L by 4–9 times. In contrast, mercury was detected at 0.0000940 mg/L, well below the permissible limit of 0.002 mg/L. Water temperature (28.7–33.3°C) and TDS (20–22 mg/L) complied with regulatory standards, while pH values ranged from 3.83 to 4.43, reflecting the natural acidity of peatland environments in the study area. The elevated cyanide levels indicate that the water in t

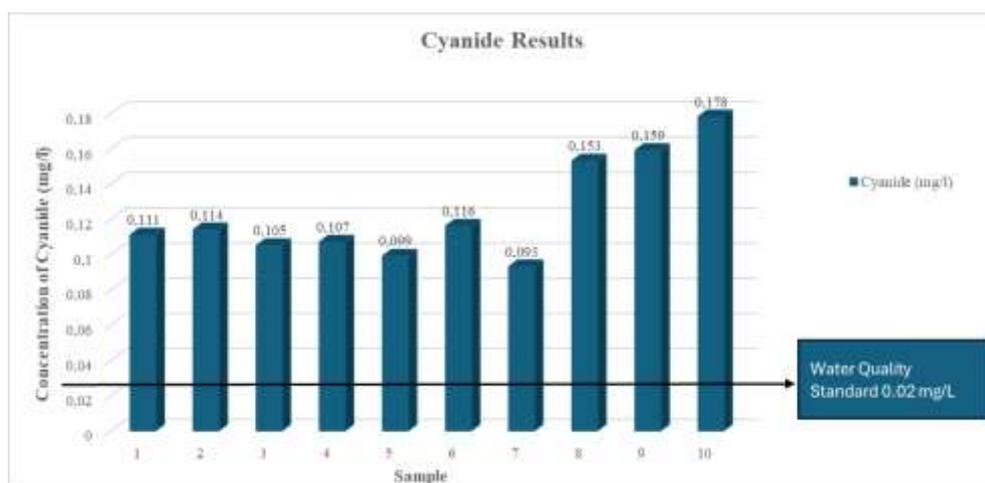
Cyanide concentrations ranged from 0,093 to 0,178 mg/L, with a mean of  $0,1235 \pm 0,0289$  mg/L ( $n = 10$ ). These values exceed the Indonesian water quality standard (0,02 mg/L; Government Regulation No. 22/2021) by approximately six times on average, indicating consistent contamination across all sampling points rather than isolated hotspots.

**Figure 2. Cyanide (CN<sup>-</sup>) Analysis Results**

Elevated cyanide levels are commonly associated with gold processing activities, particularly in poorly managed or illegal mining operations. Similar patterns of mining-related water contamination have been reported in other regions [15], [16]. In illegal mining contexts, the absence of environmental controls increases the likelihood of residual chemical persistence [17].

The acidic conditions observed in this study (mean pH 4,17) may enhance cyanide toxicity, as low pH favors the formation of hydrogen cyanide (HCN), a more toxic species. Acidic mine environments can also increase contaminant mobility and ecological risk [18].

Given the relatively stagnant nature of abandoned mining pits, dilution potential is limited, allowing contaminants to persist. Potential exposure pathways include aquatic ecosystem exposure, groundwater interaction, and direct human contact. Cyanide inhibits cellular respiration and can cause acute toxicity at elevated concentrations. Considering that measured levels substantially exceed regulatory limits, the water cannot be considered environmentally safe. Effective management or remediation is therefore necessary to prevent long-term ecological impacts [19].

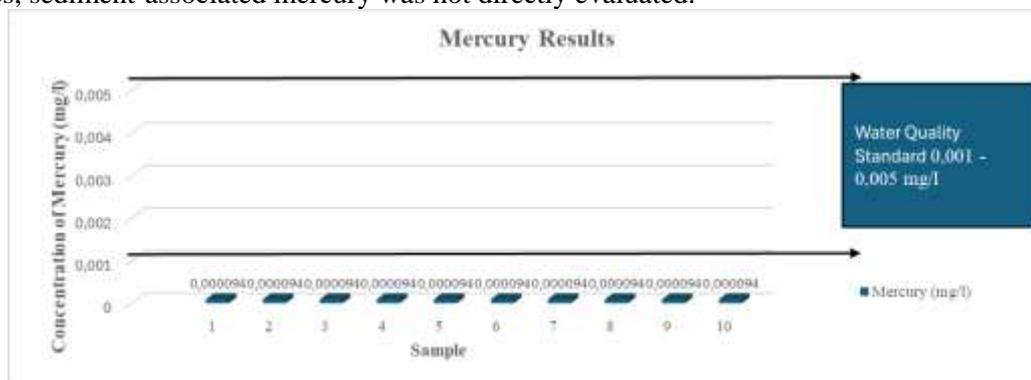
Based on laboratory analyses of water samples collected from 10 points in the abandoned artisanal and small-scale gold mining (ASGM) ponds in Sungai Pelang Village, the detected mercury (Hg) concentration at all sampling points was uniformly reported as 0,0000940 mg/L. This uniformity is attributable to the analytical method detection limit (MDL) applied during laboratory testing. The reported value represents the lowest quantifiable concentration measurable by the instrument, indicating that mercury was present at trace levels but remained below the reliable quantification range. Therefore, the identical values do not imply homogeneous environmental concentrations but rather reflect methodological reporting limitations.

Referring to Government Regulation No. 22 of 2021 (Annex VI – Surface Water Quality Standards), the maximum permissible limit for mercury (Hg) is 0,002 mg/L. The detected concentration corresponds to only 4.7% of the regulatory threshold, indicating compliance with national water quality standards. Nevertheless, the presence of mercury, even at trace levels, warrants attention due to its persistence, toxicity, and potential transformation into methylmercury (MeHg), which is bioaccumulative and poses ecological and human health risks.

Figure 3. Mercury (Hg) Analysis Results

The relatively low mercury concentration in surface water at the study site may be influenced by several factors. First, the cessation of ASGM activities has eliminated active pollutant inputs. A study conducted in Tambang Sawah, Bengkulu, reported low mercury concentrations in river water (0.0011 ppm) but substantially higher concentrations in sediments (114,37 ppm), indicating that mercury tends to accumulate in sediments following the termination of mining activities [20].

Second, mercury exhibits strong affinity for particulate matter and organic material, promoting rapid sedimentation in aquatic systems. Research has shown that mercury concentrations are typically highest in sediments, intermediate in aquatic biota, and lowest in surface waters [21]. This behavior supports the likelihood that residual mercury at the study site may be predominantly sediment-bound rather than dissolved in the water column. Given that sampling in this study focused on surface grab samples, sediment-associated mercury was not directly evaluated.

Third, the transition from mercury amalgamation to cyanide-based processing in certain ASGM areas may have contributed to reduced mercury inputs. Evidence from small-scale mining regions indicates that shifts toward cyanide leaching can significantly decrease mercury contamination in aquatic environments [22]. However, while mercury levels may decline, other environmental risks such as cyanide contamination may emerge.

Overall, although measured mercury concentrations in surface water comply with regulatory standards, the potential presence of sediment-bound mercury cannot be excluded. Further investigation involving sediment analysis would be necessary to comprehensively evaluate long-term environmental risk in abandoned illegal mining ponds.

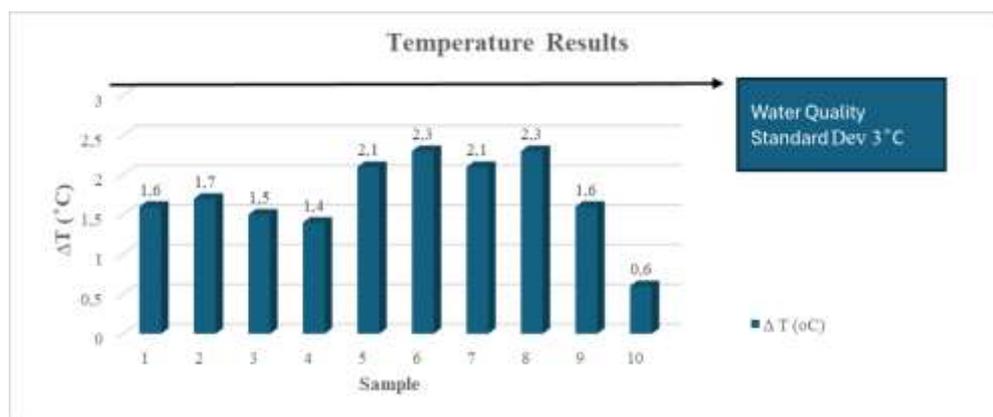
According to Government Regulation No. 22 of 2021, the permissible threshold requires that the difference between surface water temperature and ambient air temperature does not exceed 3°C. Field measurements showed water temperatures ranging from 28.7–33.3°C, while ambient air temperature averaged 31°C. The calculated temperature differences (0.6–2.3°C) remained within the regulatory threshold. This finding is consistent with [23], which stated that elevated temperatures occur because water quality measurements were conducted under extremely hot field conditions at midday in an open area without vegetation cover, where the water surface was directly exposed to sunlight.

**Figure 4. Temperature Analysis Results**

Although temperature values comply with the standard, thermal conditions play an important role in chemical dynamics within mining voids. Elevated temperatures, particularly under direct solar exposure in unvegetated open pits, may accelerate chemical reactions and increase the volatility of certain compounds. In acidic conditions (mean pH 4.17), higher temperatures can enhance the transformation of cyanide species, potentially increasing the proportion of hydrogen cyanide (HCN),

which is more toxic and volatile. Thus, while temperature itself does not exceed regulatory limits, it may indirectly influence contaminant behavior and environmental risk within the pond system.

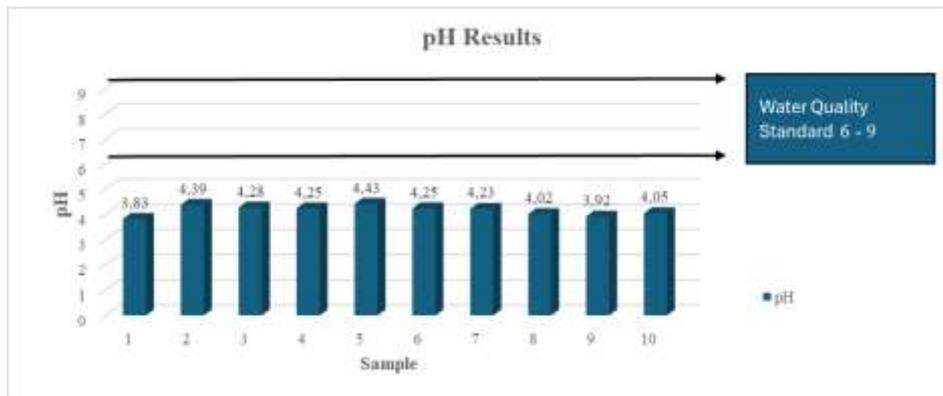
According to Government Regulation No. 22 of 2021, the permissible pH range for surface water is between 6 and 9. The pH parameter was measured directly in the field. The following figure presents a comparison of pH values in abandoned illegal gold mining ponds with the standards established by Government Regulation No. 22 of 2021.

The study site lies in a lowland area characterized by swamps with the potential presence of peat soil. Based on regional peatland characteristics and field observations, this study interprets peat soil as contributing to the low pH of the water, resulting in acidic conditions. Government Regulation No. 22 of 2021 (Annex VI) does not impose standard pH limits on peat water, as the regulation recognizes acidity as a natural characteristic of peatland ecosystems. This finding aligns with Waryati et al. [24], who reported that peat water in Kalimantan naturally exhibits a pH range of 3–5. Consequently, this study does not use the measured pH value of 4 as an indicator of compliance with surface water quality standards. High concentrations of dissolved organic matter, particularly humic acids, drive the acidic condition of peat water. Therefore, this study classifies the measured pH value of 4 as a natural characteristic of peat-influenced water and does not consider it a determinant of environmental water quality compliance.

Figure 5. pH Analysis Results

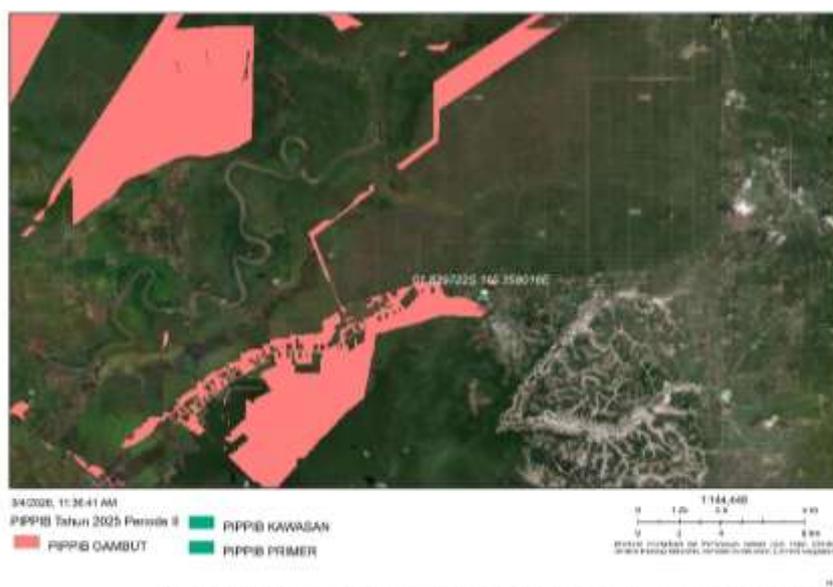
Figure 6. Interactive Map of Ketapang Peatlands

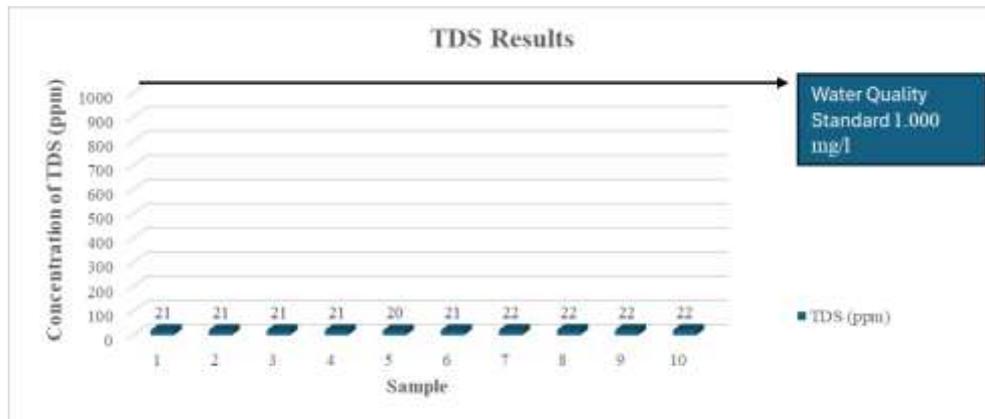
**Figure 6. TDS Analysis Results**

The measurement of Total Dissolved Solids (TDS) was conducted directly in the field. The following figure presents a comparison of TDS levels in water from abandoned illegal gold mining ponds with the standards stipulated in Government Regulation No. 22 of 2021.

Field measurements indicated that Total Dissolved Solids (TDS) levels ranged between 20–22 mg/L, which represents approximately 2% of the maximum allowable limit (1,000 mg/L) under Government Regulation No. 22 of 2021. These values classify the pond water as very low in dissolved mineral content.

Low TDS suggests limited overall ionic strength in the water column, indicating that the system does not contain high concentrations of dissolved salts or mineral residues. However, low TDS does not imply the absence of chemical contamination. Cyanide concentrations were significantly elevated despite the low TDS values, demonstrating that specific toxic contaminants may occur even when total dissolved solids remain minimal. This finding highlights that TDS alone cannot serve as a proxy indicator for chemical safety in abandoned mining pits.

Furthermore, in acidic peat-influenced waters, low mineral buffering capacity combined with low TDS may reduce the system's ability to neutralize contaminants. Consequently, although the TDS parameter complies with regulatory standards, the overall environmental risk remains governed primarily by the elevated cyanide concentration and its chemical behavior under acidic conditions.
